## **CC430F6135 Device Erratasheet**

### **1 Revision History**

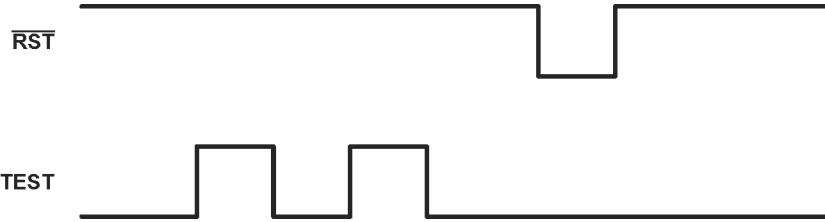
The methods used to exit the BSL per MSP430 Programming Via the Bootstrap Loader ([SLAU319](#)) are invalid.

<b>Workaround</b>	To exit the BSL one of the following methods must be used. <ul style="list-style-type: none"> <li>- A Power cycle</li> <li>or</li> <li>- Toggle the TEST pin twice when nRST is high and after 50us pull nRST low.</li> </ul>

<p>Note: This toggling of TEST pins is not subject to timing constraints. The appropriate level transitions on TEST pin, followed by a RST pulse after 50us, are sufficient to trigger an exit from BSL mode.</p>
<b>JTAG26</b>	<b>JTAG Module</b>
<b>Function</b>	LPMx.5 Debug Support Limitations
<b>Description</b>	<p>The JTAG connection to the device might fail at device-dependent low or high supply voltage levels if the LPMx.5 debug support feature is enabled. To avoid a potentially unreliable debug session or general issues with JTAG device connectivity and the resulting bad customer experience Texas Instruments has chosen to remove the LPMx.5 debug support feature from common MSP430 IDEs including TIs Code Composer Studio 6.1.0 with msp430.emu updated to version 6.1.0.7 and IARs Embedded Workbench 6.30.2, which are based on the MSP430 debug stack MSP430.DLL 3.5.0.1 <a href="http://www.ti.com/tool/MSPDS">http://www.ti.com/tool/MSPDS</a></p> <p>TI plans to re-introduce this feature in limited capacity in a future release of the debug stack by providing an IDE override option for customers to selectively re-activate LPMx.5 debug support if needed. Note that the limitations and supply voltage dependencies outlined in this erratum will continue to apply.</p> <p>For additional information on how the LPMx.5 debug support is handled within the MSP430 IDEs including possible workarounds on how to debug applications using LPMx.5 without toolchain support refer to <a href="#">Code Composer Studio User's Guide for MSP430 chapter F.4</a> and <a href="#">IAR Embedded Workbench User's Guide for MSP430 chapter 2.2.5</a>.</p>
