MSP430F5638 Device Erratasheet

1 Revision History

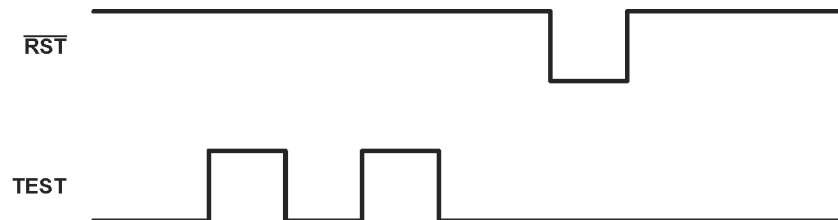
Function	BSL does not exit to application code
Description	The methods used to exit the BSL per MSP430 Programming Via the Bootstrap Loader (SLAU319) are invalid.
Workaround	To exit the BSL one of the following methods must be used.

- A Power cycle
- or
- Toggle the TEST pin twice when nRST is high and after 50us pull nRST low.

Note: This toggling of TEST pins is not subject to timing constraints. The appropriate level transitions on TEST pin, followed by a RST pulse after 50us, are sufficient to trigger an exit from BSL mode.
