MSP430F5326 Device Erratasheet

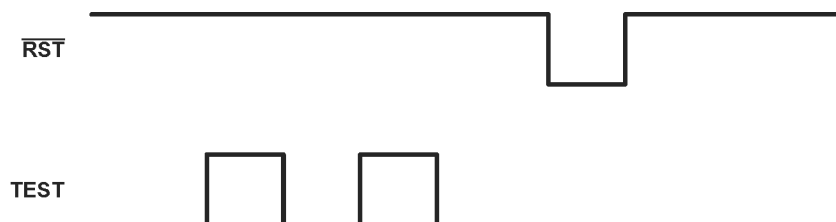
Function	BSL does not exit to application code
Description	The methods used to exit the BSL per MSP430 Programming Via the Bootstrap Loader (SLAU319) are invalid.
Workaround	To exit the BSL one of the following methods must be used.

- A Power cycle
- or
- Toggle the TEST pin twice when nRST is high and after 50us pull nRST low.

Note: This toggling of TEST pins is not subject to timing constraints. The appropriate level transitions on TEST pin, followed by a RST pulse after 50us, are sufficient to trigger an exit from BSL mode.
