MSP430G2212 Device Erratasheet

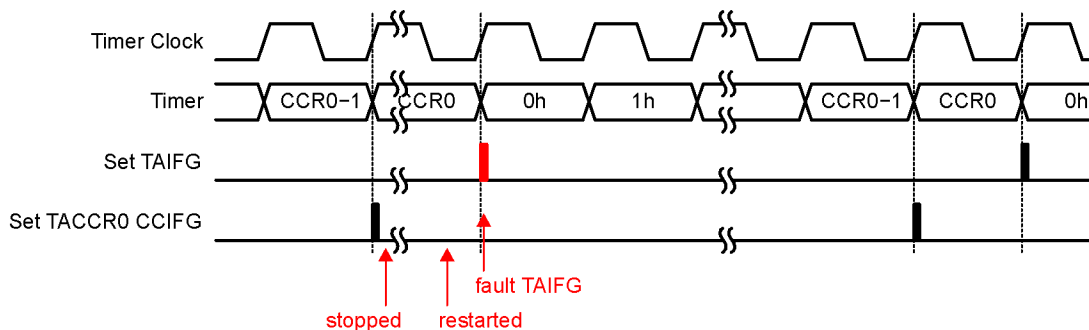
Function TAIFG Flag is erroneously set after Timer A restarts in Up Mode

Description In Up Mode, the TAIFG flag should only be set when the timer counts from TACCR0 to zero. However, if the Timer A is stopped at TAR = TACCR0, then cleared (TAR=0) by setting the TACLR bit, and finally restarted in Up Mode, the next rising edge of the TACLK will erroneously set the TAIFG flag.

Workaround None.
