TMS320F281x, TMS320C281x DSPs Silicon Revisions G, F, E, D, C, B, A, 0

1 Introduction

This document describes the silicon updates to the functional specifications for the TMS320F2810, TMS320F2811, TMS320F2812, TMS320C2810, TMS320C2811, and TMS320C2812 digital signal processors (DSPs).

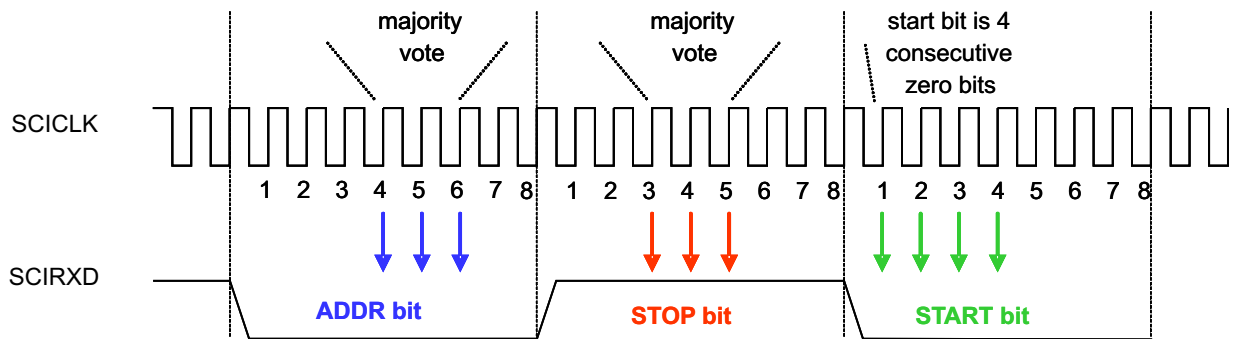
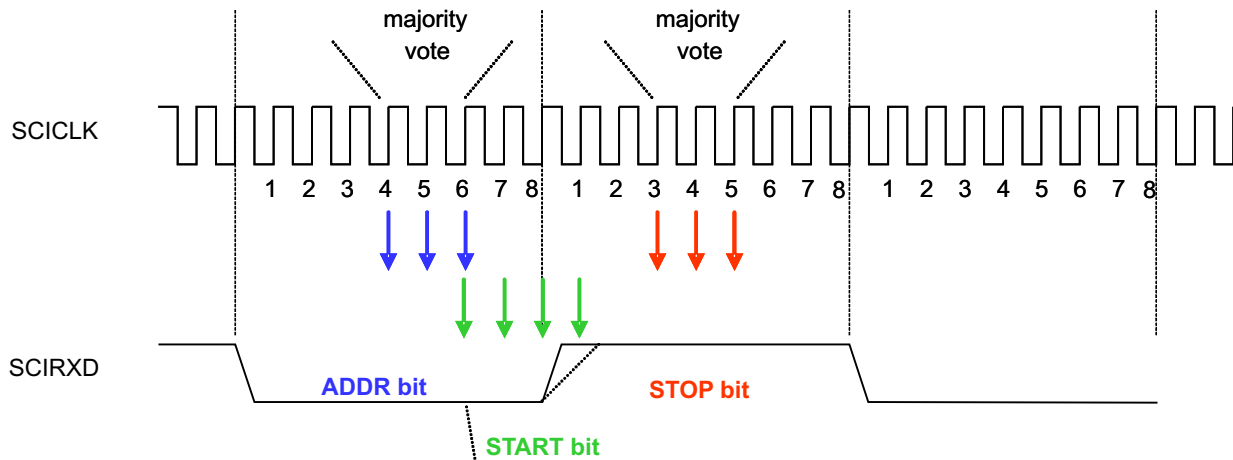
Figure 3. Difference Between Expected and Erroneous Operation of START Bit

Details The SCI does not look for the STOP bit after the ADDR bit. Instead, the SCI starts looking for the start bit beginning on sub-sample 6 of the ADDR bit. Slow rise time from the ADDR bit to the STOP bit can cause a false START bit to occur since the 4th sub-sample for the start bit may be sensed low.

Workaround(s) Program the baud rate of the SCI to be slightly slower than the actual. This will cause the 4th sub-sample of the false START bit to be delayed in time, and therefore occur more towards the middle of the STOP bit (away from the signal transition region). The amount of baud-slowng needed depends on the rise time of the signal in the system. Alternatively, the IDLE mode of the SCI module may be used, if applicable.
