MSP430F5524 Device Erratasheet

1 Revision History

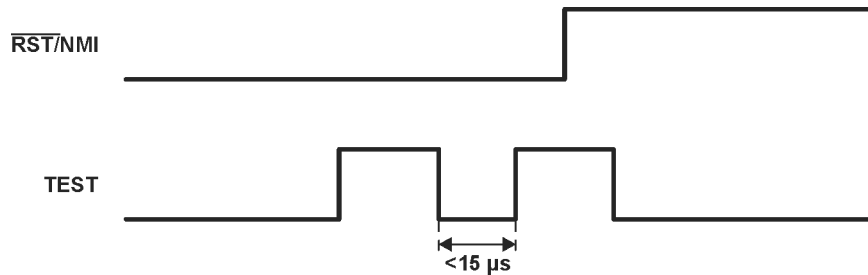
The BSL entry sequence requires that the low phase of the TEST/SBWTCK pin does not exceed 15us. This timing requirement is faster than most PC serial ports can provide, as shown in the following picture. If this requirement is not met, the entry sequence fails and the SYSBSLIND is not set.

Workaround An external hardware solution is recommended to provide the appropriate BSL entry sequence. See [http://processors.wiki.ti.com/index.php/BSL_\(MSP430\)](http://processors.wiki.ti.com/index.php/BSL_(MSP430)) for recommendations on available BSL hardware.
